PERFORMANCE AUDIT REPORT

Toronto, Ontario

Ben Engineering, Inc.

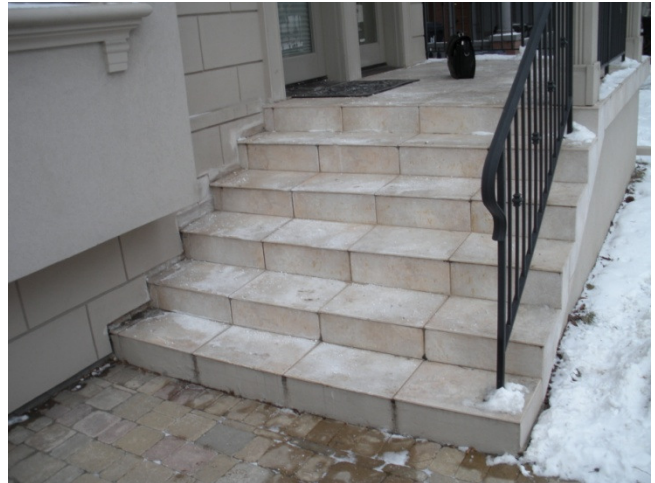
6.2.1.2 The porch and the stair treads at the entrance to units 2 and 3 are paved with ceramic tiles that tend to be slippery when wet, and therefore might become a safety issue.

The stairs leading to Units 2 and 3.

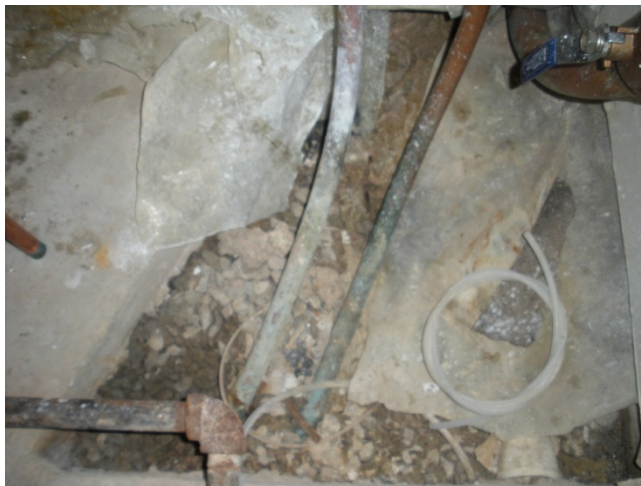
6.1.1.2 Two of the copper pipes beneath the main water meter on the east side of the basement appear to be highly corroded. There is no practical way to inspect the condition of other pipes concealed beneath the floor.

Corroded copper pipes below the main water meter on the east side of the basement.

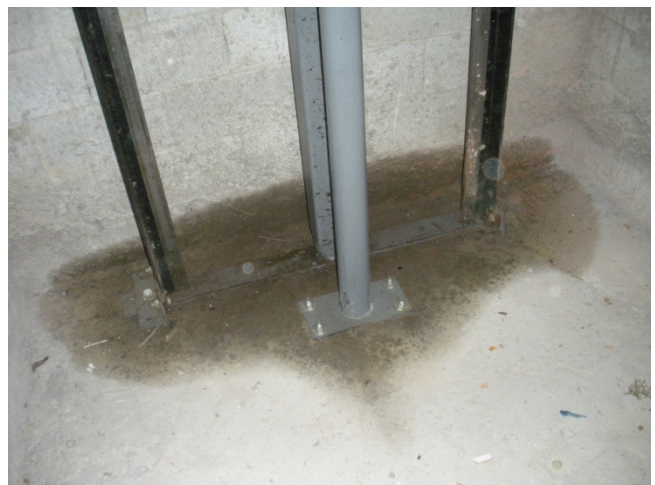
6.3.2 There is an oil stain on the floor below the elevator pole and oil remaining on the pole itself, which indicates a possible oil leakage from the hydraulic elevator system. (Note: in accordance to Section 4.3(b) of the Disclosure Statement, and Sections 4.04 and 5.03 of the Declaration, the elevator is exclusively used by the upper units, Units 2 and 3).

Oil stain on the floor beneath the hydraulic elevator in the elevator's mechanical room.

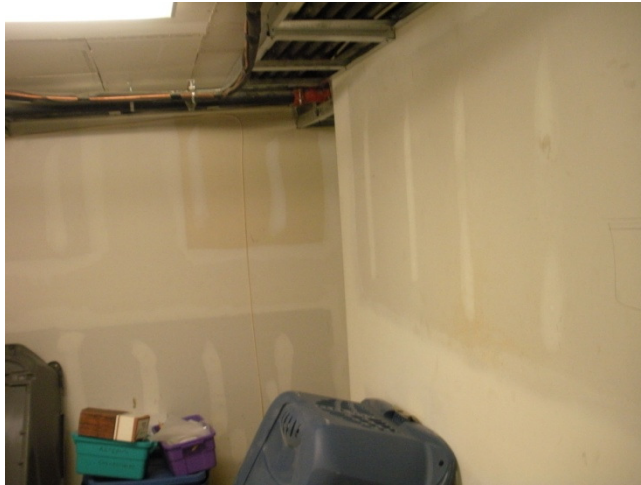
6.1.1.1 The walls and the ceiling of the basement are partly finished. In some places no mortar was applied to seal the seams between the gypsum boards, there are some holes, and the ceiling and the walls have not been painted.

The walls in the basement.
